POST HOSPITAL CONCEPTUAL REUSE PLAN

Fort Vancouver National Site

April 8, 2013

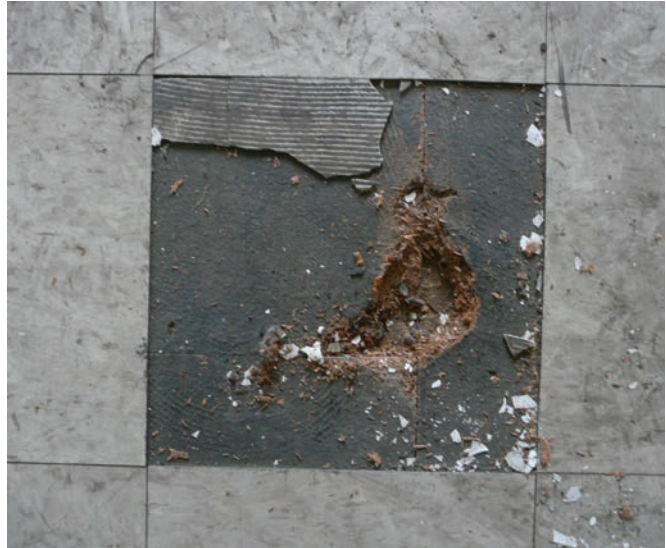
It is assumed that this represents only a partial listing of all hazardous materials in the building. As part of this study, Steve Dilling from PBS Environmental was invited to tour the building and provide comments regarding the hazardous materials situation. Mr. Dilling warned about conditions such as lead paint on the windows, doors, tin ceilings, and the mortar wash. The perimeter of the building will need to be tested for the spread of lead dust contamination in the dirt. Mr. Dilling suggested testing for asbestos at the window glazing, the stair treads and risers, and plasterwork. The (likely) asbestos mastic applied over the wood floors will be very difficult to remove, and could require the entire removal of the finished wood flooring.

Layers of flooring, some of which are anticipated to contain hazardous materials.

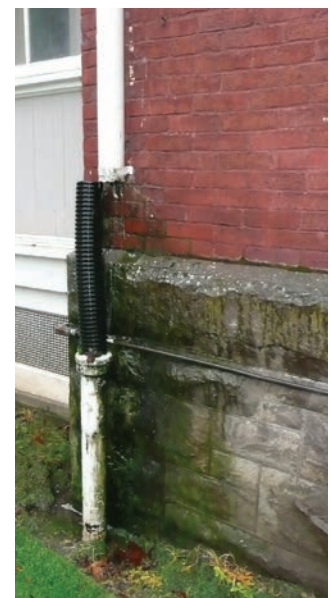
Damage to brick and stone due to disconnected downspout.

The Tenino sandstone used principally at the Main Building and the Wings is notorious for deteriorating at a rate quicker than other stone material. This is especially true when consistent moisture is introduced, such as at downspout locations. Biological growth occurs at these locations and at the top of the watertable, adding to the potential for deterioration. With the rather delicate nature of the sandstone, these localized issues should be addressed. Overall, the stone foundations appear to be in fair condition. The stone window sills appear to be in fair-to-good condition, with occasional visible cracks, and the spalling of corners.

The most immediate action is to protect the foundation from moisture damage. Downspouts are to be properly reinstalled to keep stormwater away from the stone. All biological growth is to be carefully removed without damaging the substrate underneath. Any severely damaged stone is to receive a consolidation process that solidifies the stone in a visually unobtrusive manner.

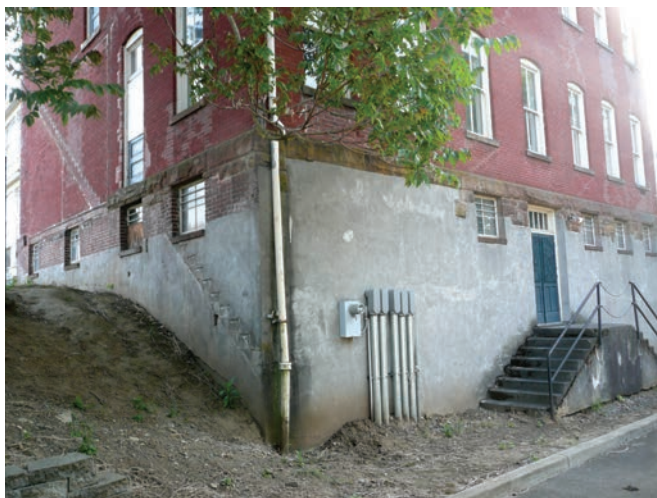
The variety of foundation materials employed at the Annex provide an inconsistent look to this portion of the Post Hospital complex. The parge coat has spalled off at the lower corner of the east elevation, exposing the concrete block structure. The window sills display a greater level of damage. Stone issues similar to that of the Main Building are also found.

Southwest corner of the Annex.

At the Annex, all areas of spalled parge coating are to be patched, and all organic growth removed.

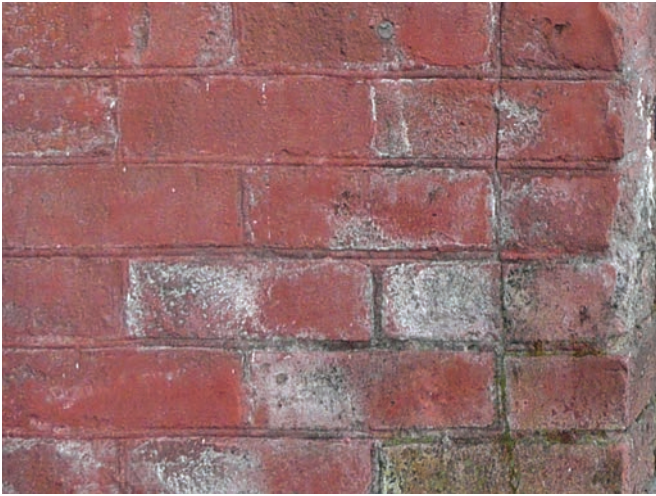
Close up of brick at the Main Building, showing the compromised weatherface due likely to sandblasting.

Years after its construction, a red mortar wash was applied over all brick walls. These walls appear to have been sandblasted to clean off surface and address the probable remnants from the vegetation that grew on the walls. Unfortunately, this has compromised the weatherface of the brick. Recent repointing work appears to have used a cement based mortar, which is much harder than the original mortar and inappropriate for this application.

Overall, the brick walls at the Main Building are in fair condition. There are various holes and chips in the brick, but no obvious crack patterns suggestive of excessive settling. Open mortar joints occur mainly near the downspout locations. There is some staining at the intersection where the east porch roof meets the wall. The greatest change to the brick was the sand blasting of the exterior face, and subsequent application of the red mortar wash.

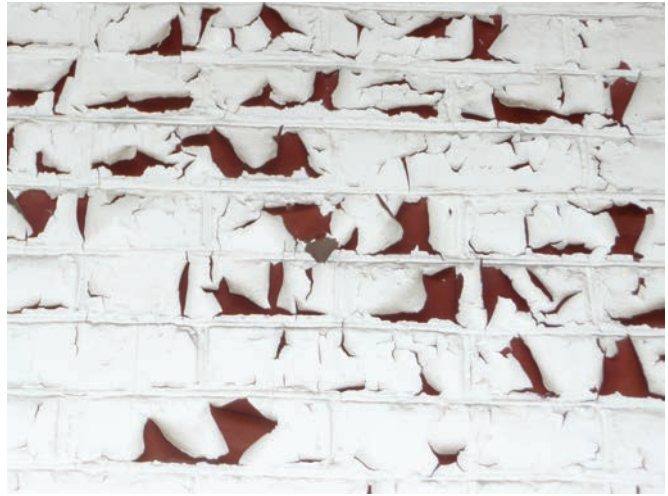
South Wing wall, with white paint applied over red mortar wash.

At the North and South Wings, the white paint applied over the brick walls is peeling, and is pulling off the outer layer of mortar wash with it. Otherwise, these walls appear to be in fair condition, due in part to their protection from the elements.

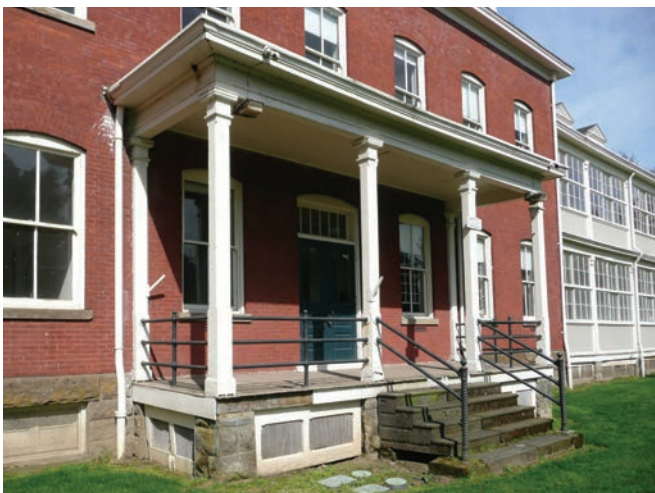
The east entry porch suffers from advanced deterioration at most all of its essential elements. The wood decking is in very poor condition, as well as the framing members beneath. The columns have areas of rot, as does the entablature system it supports. Though the roof was not accessible for viewing, water staining along the fascia prompts the assumption that it is not performing adequately. The pipe rails require reworking to comply with guardrail height and fall restraint requirements.

East porch, the formal entry into the Post Hospital.

The east porch should be reconstructed in a manner that reuses as much historic fabric as is allowable. The new porch should be structurally sound, and address weather wear and long term durability. All pipe rails are to be made code compliant. As part of this reconstruction, the porch deck should be raised up to the height of the interior finished floor, for accessibility purposes. Also, a new ADA ramp connecting to this reconstructed porch should be explored.

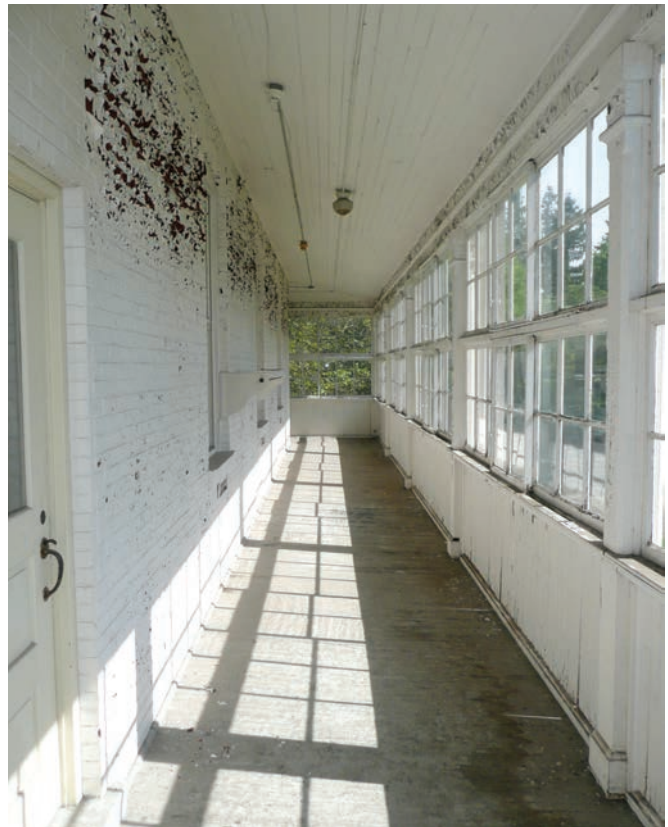
Interior condition of the North Wing porch.

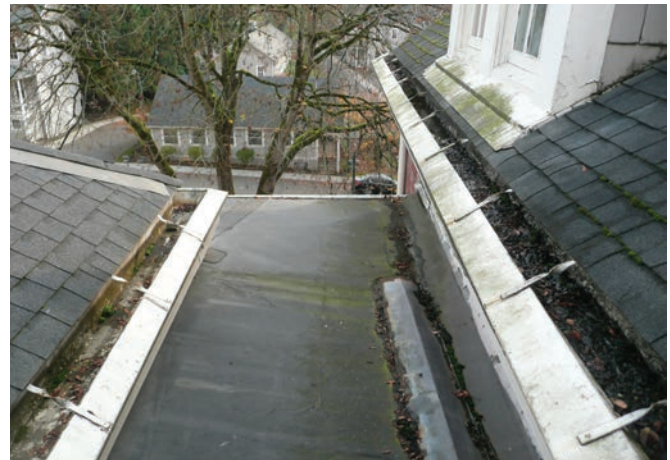
Built-in gutter system of the South Wing and the Annex.

All built-in gutter locations should be carefully deconstructed to determine the extent of damage to the framing members, and repaired. Any opportunity to increase the capacity of the gutters should be explored. All storm sewer lines should be cleared of debris, and new downspouts installed.

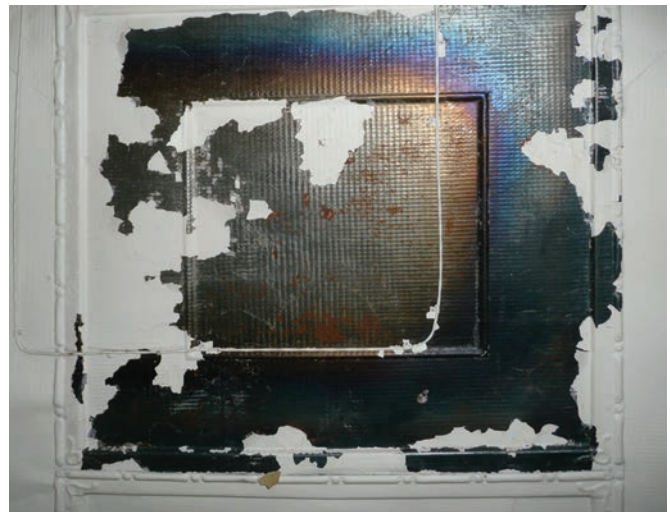
Close up image of a tin ceiling panel.

The tin ceilings will either have to have the lead paint removed and be repainted, or have that lead paint encapsulated. The final direction could depend on the need to remove the tin panels for the installation of services within the ceiling plenum. If the paint is to be removed, it should be investigated if the removal of the tin panels would expedite this process, or not.
