POST HOSPITAL CONCEPTUAL REUSE PLAN

Fort Vancouver National Site

April 8, 2013

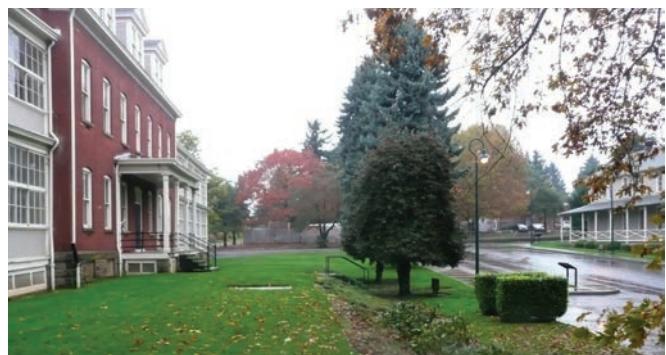
The east yard, looking north.

The site landscape at the eastern yard is in good condition and well maintained. The western yard is unmaintained, but relatively clear of debris.

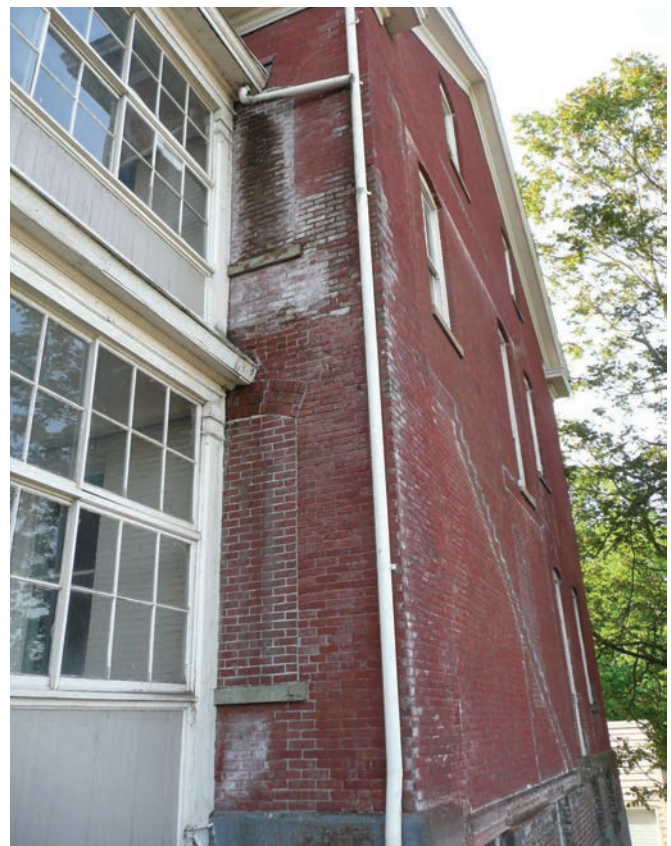
Northwest corner of the Annex.

Annex: The annex shows a greater level of repointing and brick repair than the other buildings in the complex. This is likely due to its 1952 relocation, an action that is taxing to an unreinforced masonry building of this size. These cracks occurred in high stress locations, such as window heads and sills, and their pattern is obvious through the repair work incorporating newer brick and unpainted mortar joints. The unpainted nature of the mortar joints suggests that the red mortar wash was applied sometime previous to 1952.

The Annex brick walls show a greater level of damage, much of which has been patched. There are open mortar joint, again occurring near downspout locations.

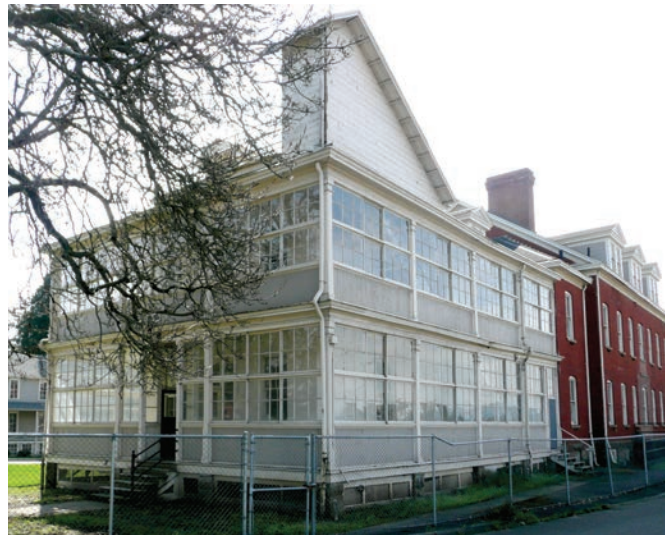
Northwest corner of the North Wing.

The exterior walls of the galleries have settled noticeably, due possibly to the additional weight the original structural framing was not designed to accommodate. Various repairs over the years have accounted for this settling, shaving down woodwork and resetting glazing to match the slopes. These irregularities have created opportunities for moisture infiltration, and its ensuing damage.

The entire west staircase at the porches of both Wings should be removed, and the vertical communication between floors handled internally with the new fire stairs.

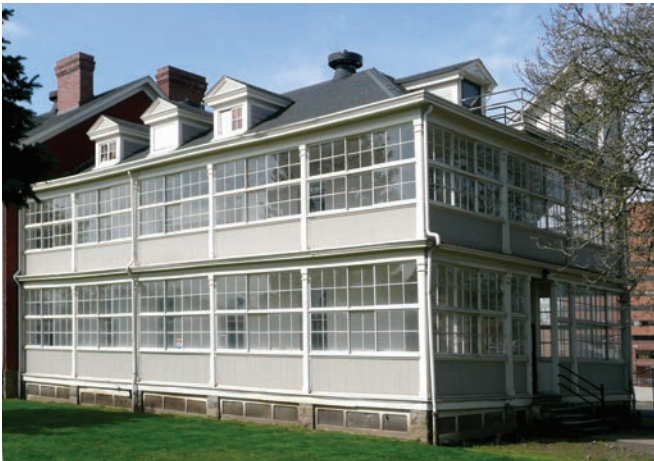
Northeast corner of the North Wing.

A new enclosure system could be designed to either replicate the current window-wall arrangement, or return the pre-1930s open porch aesthetic, while maintaining weather protection. For instance, a glazing system could be designed with minimal framing that would maintain an open look, while keeping out moisture and reducing heat transference. The pipe rail would be returned, completing the look. If maintaining the post-1930s look with the galleries is desired, then a new wall and glazing system could be created to resemble the existing, but with better sound and thermal qualities and greater durability. New utilities should be located in the walls as well, such as power outlets.

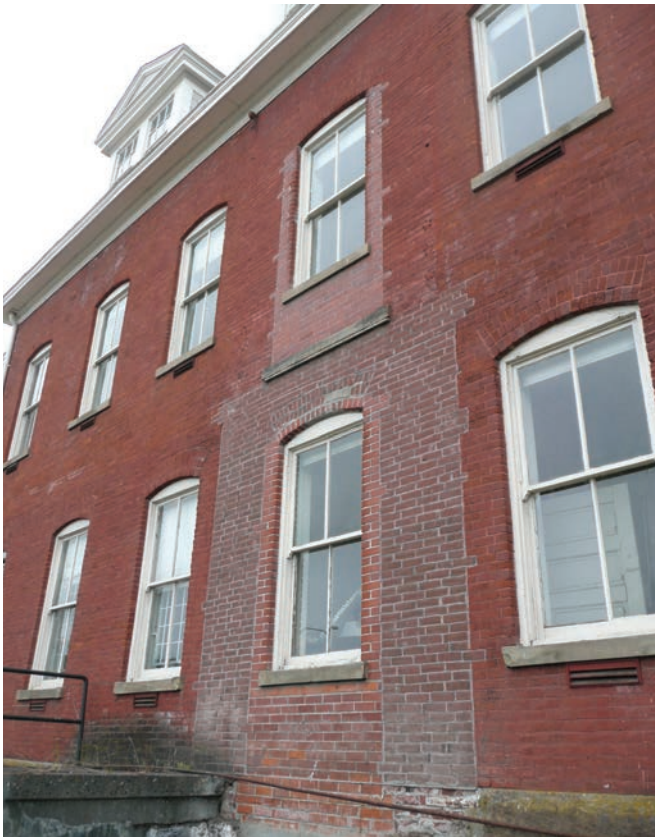
Overall, the windows are in fair condition. An item of concern is that these windows have likely retained their initial coat of lead paint, which could allow particles of lead to become friable through constant operation. It is also possible that the glazing compound could contain asbestos.

Windows at the Main Building's west elevation. Visible are the sections of infilled wall from an early connection to the Annex.

The windows should be tested for lead paint and any asbestos containing materials. If lead paint is confirmed and the windows are to be operable as part of the ventilation strategy, then the sashes should be removed, stripped to bare wood, and repainted. It might be possible to encapsulate the glazing compound if it is found to contain asbestos. Windows are to be returned to their original locations, and adjusted to ensure ease of operation.

Another possible manner of addressing the hazardous material issue is to not use the windows for any required ventilation, and instead fix them closed. Internal storm sashes could also be added to provide additional thermal and sound insulation.

Finally, the windows originally had external shutters, and it should be considered to return these character-defining features back to the building.

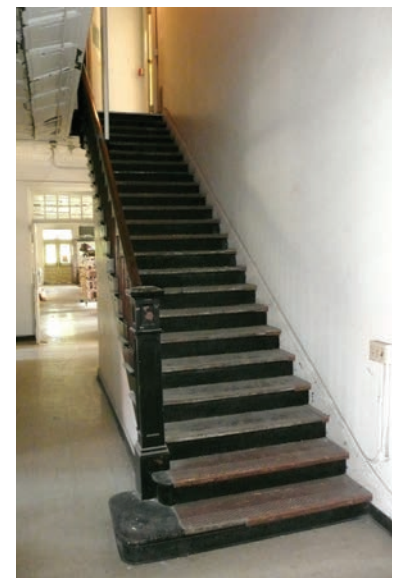
The open stair in the Main Building.

The first floor stairs in the Main Building are in good condition, with a number of the vinyl treads removed. Other stairs throughout the complex have had original wood elements removed as part of their enclosure.

The stair from the first to the second floor at the Main Building should be restored and fully opened between floors, retaining a character defining feature between the two principal floors. A code compliant handrail should be provided along the wall, and the proper guardrail around the opening. The remainder of the stair system should be removed, and a new code compliant fire stair created at another location that connects all floors and provides the necessary path of egress.

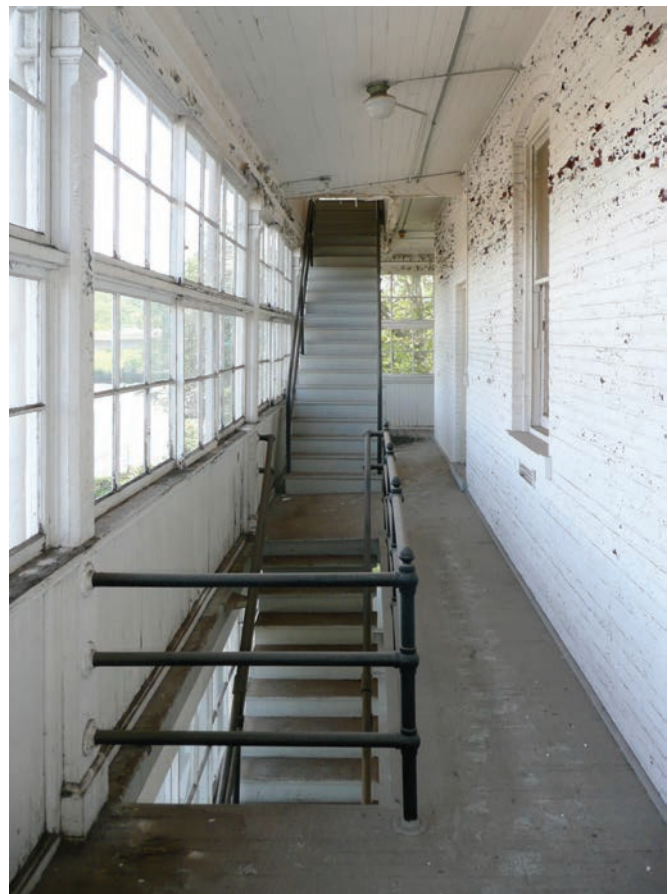
Porch stairway at second floor of the North Wing.

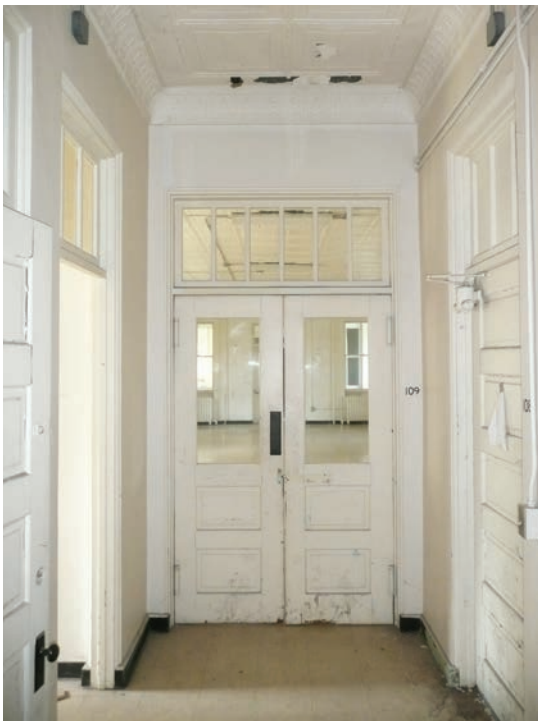
The doors are in fair-to-good condition, and repairable.

Examples of interior doors and relights.

All original doors should be cleaned, patched as required, and painted. Code compliant hardware should be provided on all doors, and might require some involved carpentry work to accommodate.

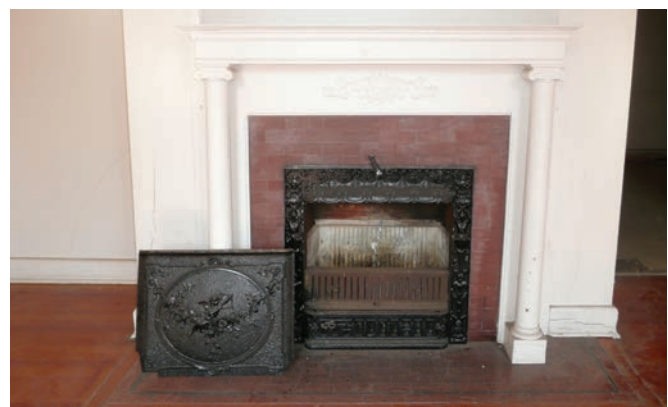
The fireplace is in good condition, though there appears to be some white efflorescence on the brick face, and a few open mortar joints.

Fireplace at Room 117.

The fireplace should be restored to original condition, which includes cleaning all the brickwork, repointing the open joints, and repainting. The flue should be checked for any damage, and the chimney cleaned. The fireplace could be fitted with a natural gas insert system, to return its original function.

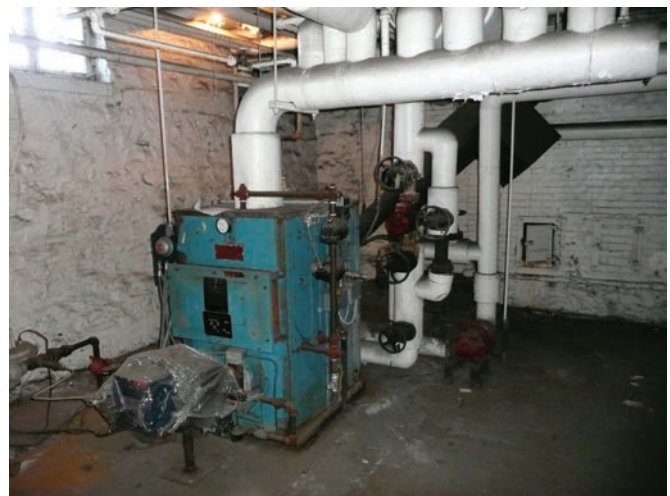
Existing boiler in the basement.

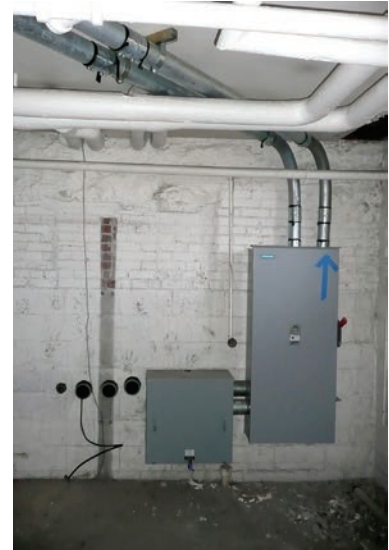
Electrical panels in the Annex.
